STEERING GEAR

POWER ASSISTED STEERING BOX

DELTA-PRISMA 4WD

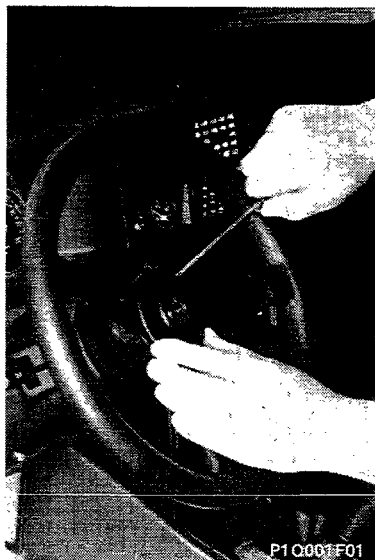
Removing-refitting steering wheel

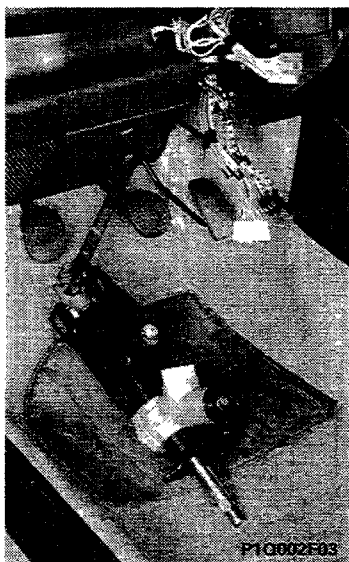
Removing-refitting lower shaft from steering box pinion

NOTE *Lastly, disconnect the upper shaft from the lower one.*

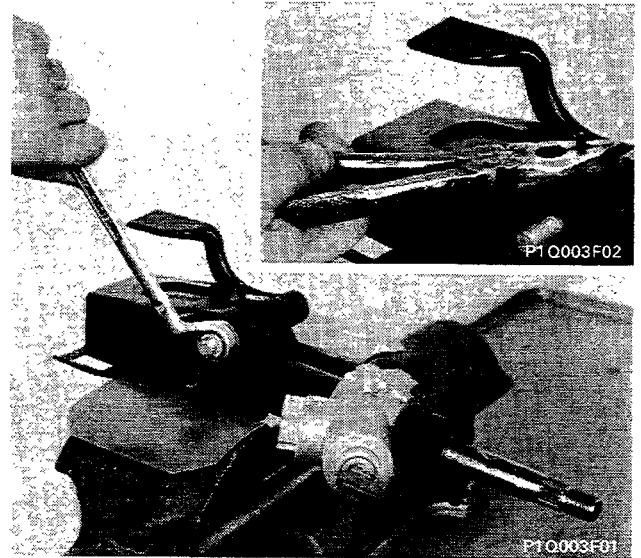
Dismantling-reassembling steering wheel height adjustment device

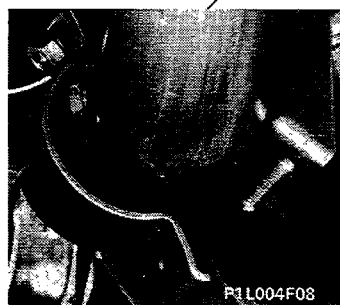
- drain the fluid from the power assisted steering reservoir, in the engine compartment;
- remove the front wheels;
- raise the lift and, from underneath the vehicle, drain the fluid from the idler unit;
- then, remove the items illustrated below:

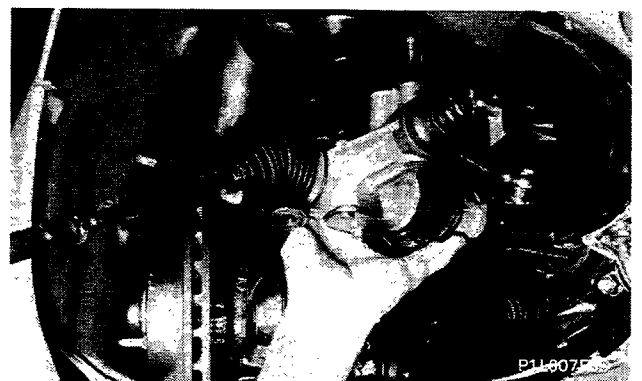
- position the hydraulic jack under the idler unit;
- then, remove the items illustrated below:

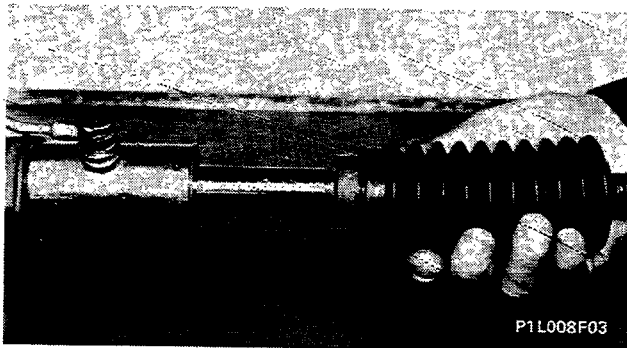
Dismantling-reassembling rod complete with track rod end
